YOUR Inspection Report

123 Your St
Some Where, BC

Friday, January 8, 2021

Report No. 1190

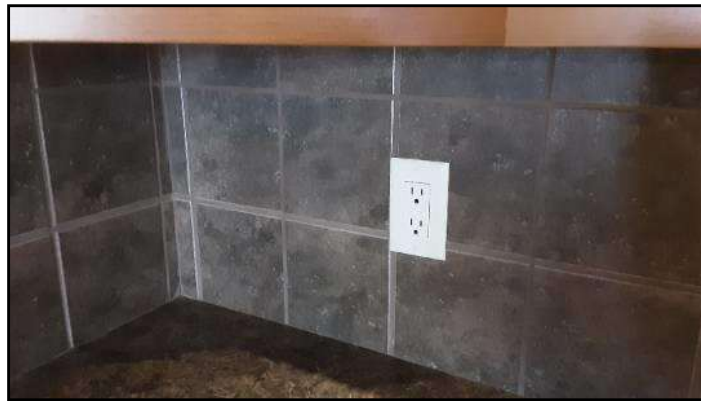
1. Loose

DISTRIBUTION SYSTEM \ Outlets (receptacles)

Condition: • Loose

Implication(s): Electric shock | Fire hazard

Location: Kitchen

Task: Repair

Time: Immediate

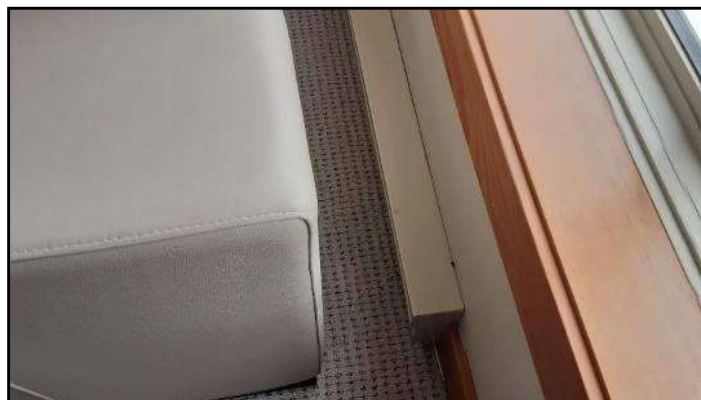
2. Won't warm up

ELECTRIC BOILER \ Radiators, convectors and baseboards

Condition: • Won't warm up

Implication(s): Chance of water damage to structure, finishes and contents | Reduced comfort

Location: Living Room

Task: Repair or replace

Time: Immediate

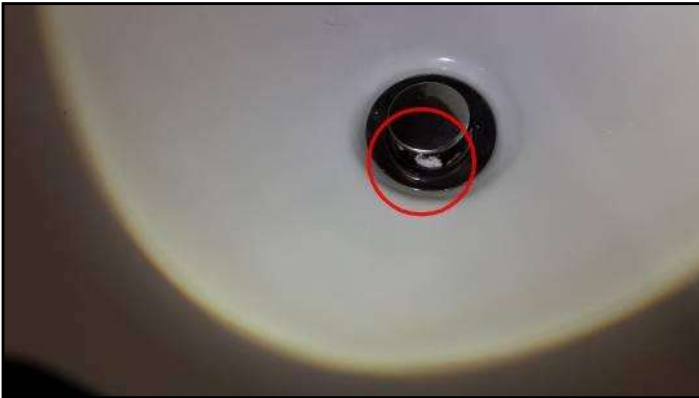
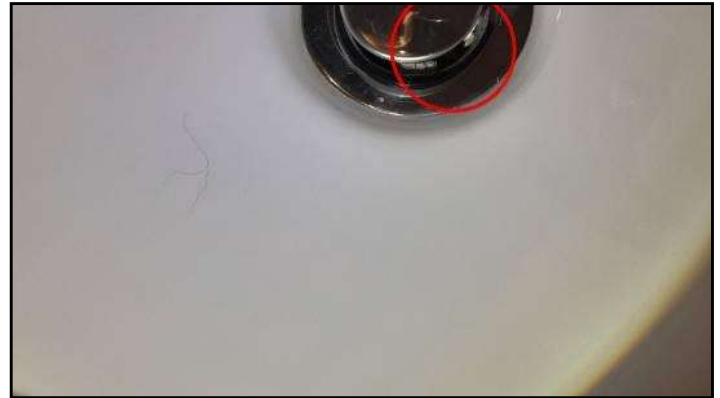
Condition: • Drain stop ineffective

There are items in the drain of the vanity sink. These stop the drain from effective and cause the sink to over flow. We recommend this be repaired by a qualified professional

Implication(s): Nuisance | Reduced operability

Location: Ensuite Bathroom

Task: Repair

Time: Immediate

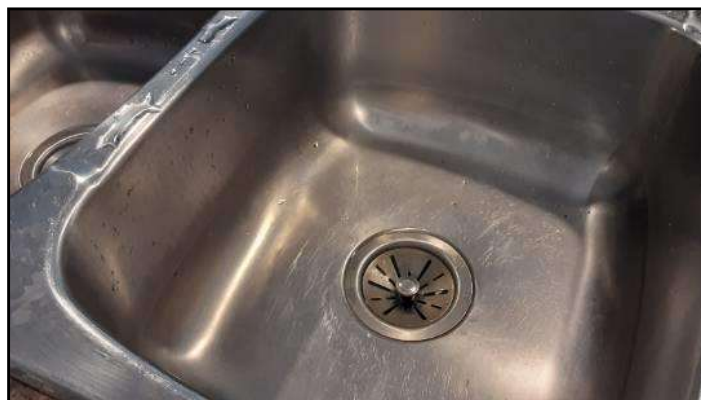
5. Drain stop ineffective

Condition: • Drain stop ineffective

The knob pulls off the drain plug so can not lift it to drain the sink.

Implication(s): Nuisance | Reduced operability

Location: Kitchen

Task: Repair or replace

Time: Immediate

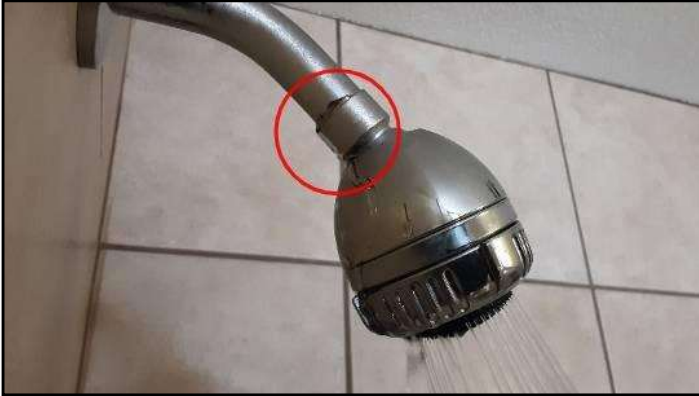
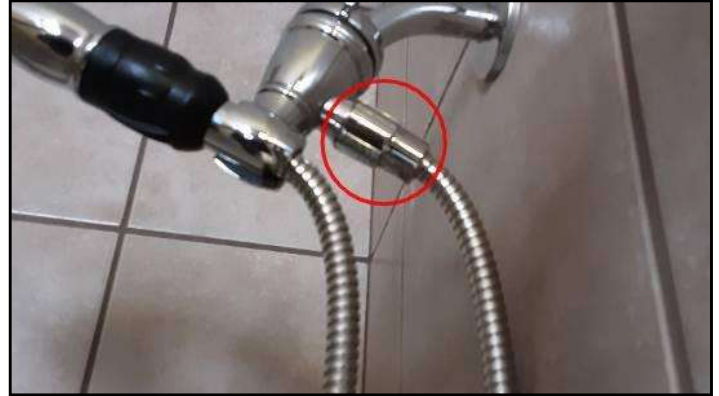
Condition: • Leak

Implication(s): Chance of water damage to structure, finishes and contents

Location: Ensuite Bathroom

Task: Repair or replace

Time: Immediate

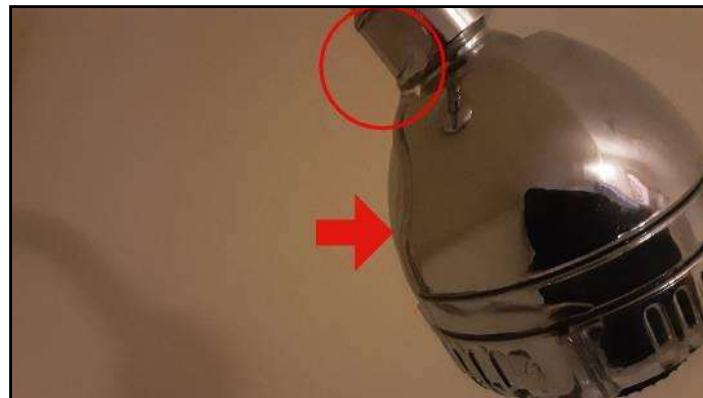
8. Leak

Condition: • Leak

Implication(s): Chance of water damage to structure, finishes and contents

Location: Bathroom

Task: Repair or replace

Time: Immediate

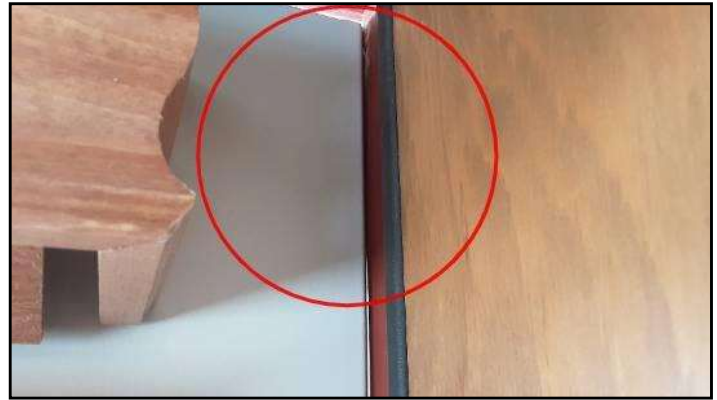
10. *Binds*

Condition: • Binds

Implication(s): System inoperative or difficult to operate

Location: Master Bedroom

Task: Repair

Time: Immediate Less than 1 year

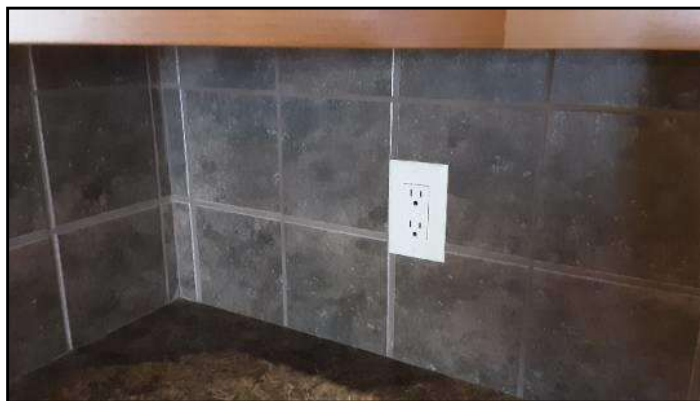
22. Loose

4. Condition: • Loose

Implication(s): Electric shock | Fire hazard

Location: Kitchen

Task: Repair

Time: Immediate

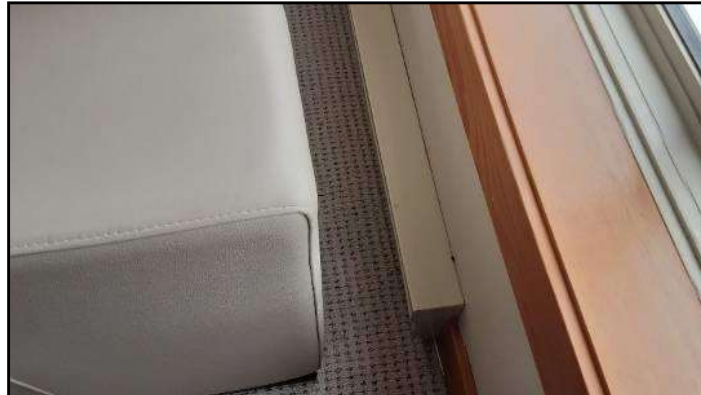
51. *Won't warm up*

6. Condition: • Won't warm up

Implication(s): Chance of water damage to structure, finishes and contents | Reduced comfort

Location: Living Room

Task: Repair or replace

Time: Immediate

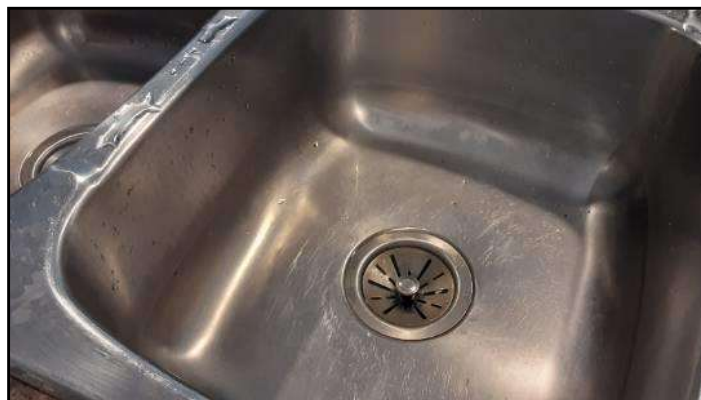
61. *Drain stop ineffective*

7. Condition: • Drain stop ineffective

The knob pulls off the drain plug so can not lift it to drain the sink.

Implication(s): Nuisance | Reduced operability

Location: Kitchen

Task: Repair or replace

Time: Immediate

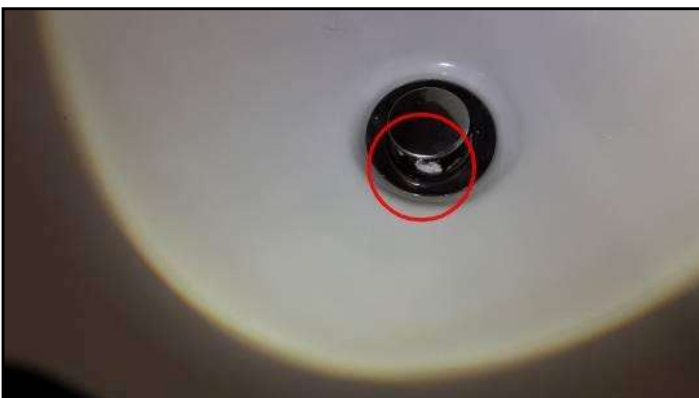
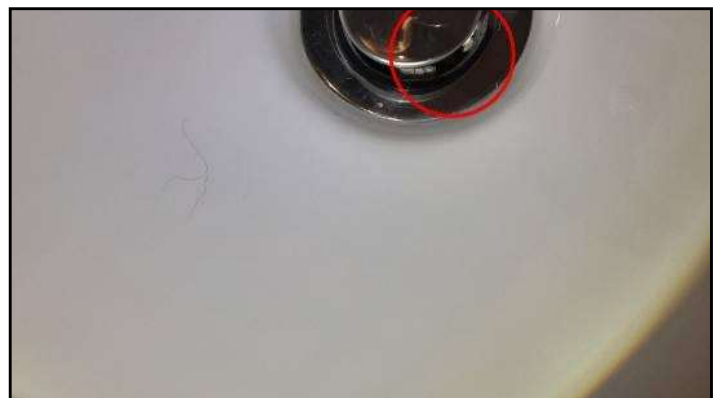
8. Condition: • Drain stop ineffective

There are items in the drain of the vanity sink. These stop the drain from effective and cause the sink to over flow. We recommend this be repaired by a qualified professional

Implication(s): Nuisance | Reduced operability

Location: Ensuite Bathroom

Task: Repair

Time: Immediate

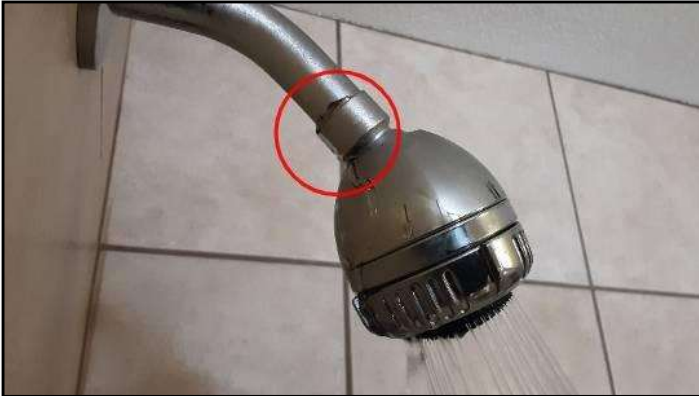
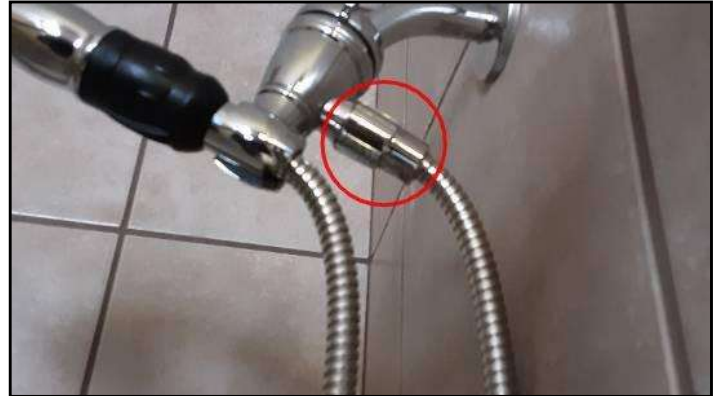
9. Condition: • Leak

Implication(s): Chance of water damage to structure, finishes and contents

Location: Ensuite Bathroom

Task: Repair or replace

Time: Immediate

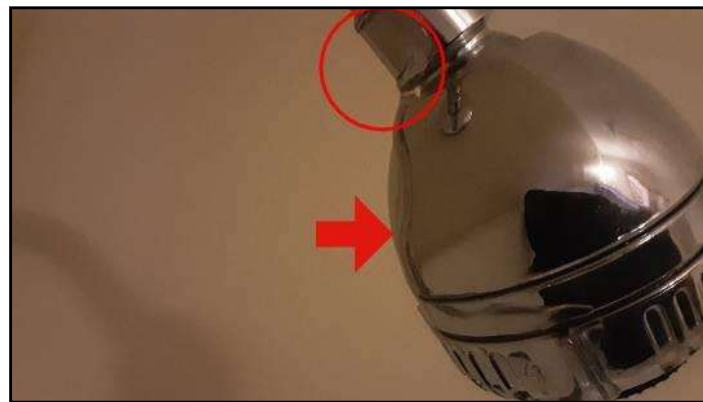
66. Leak

10. Condition: • Leak

Implication(s): Chance of water damage to structure, finishes and contents

Location: Bathroom

Task: Repair or replace

Time: Immediate

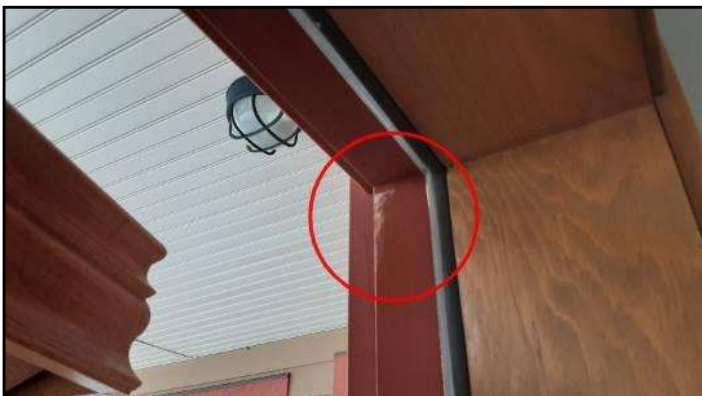
67. Binds

13. Condition: • Binds

Implication(s): System inoperative or difficult to operate

Location: Master Bedroom

Task: Repair

Time: Immediate Less than 1 year
