YOUR Inspection Report

123 Your ST
Somewhere, BC

SAMPLE REPORT

Monday, December 14, 2020

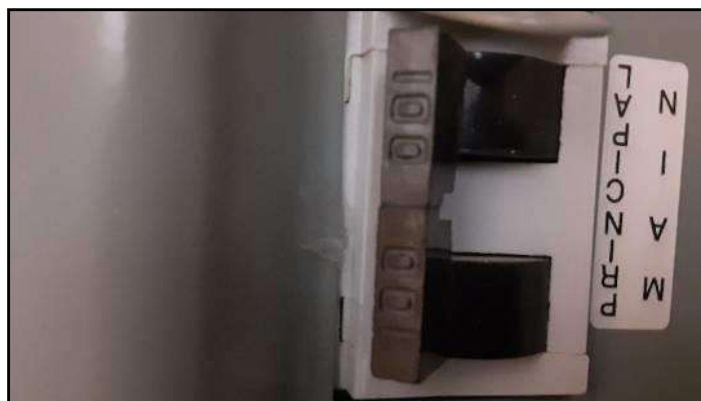
10. 100 Amps

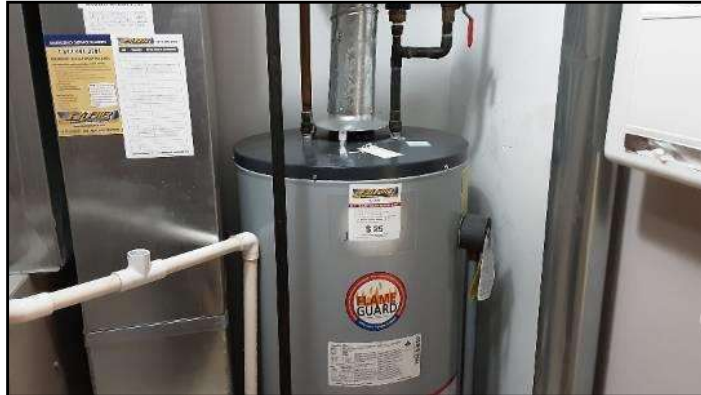
29. Conventional

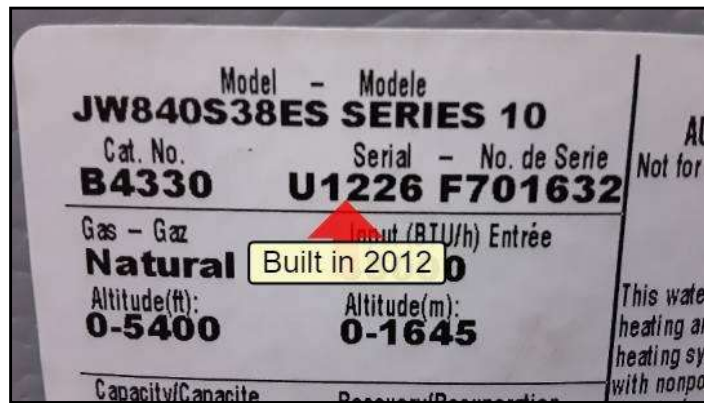
31. 8 years

5. Condition: • Near end of life expectancy

The average domestic hot water heater has a life expectancy of 8-12 yrs. At these ages there may also be insurance implications.

We recommend that a hot water heater be replaced by a qualified professional when required.
