YOUR Inspection Report

123 Your ST
Somewhere, BC

Thursday, September 3, 2020

Stix Property Inspections - Lic 80281
3211 Skyview Ln, Suite 203
West Kelowna, BC V4T 3J3

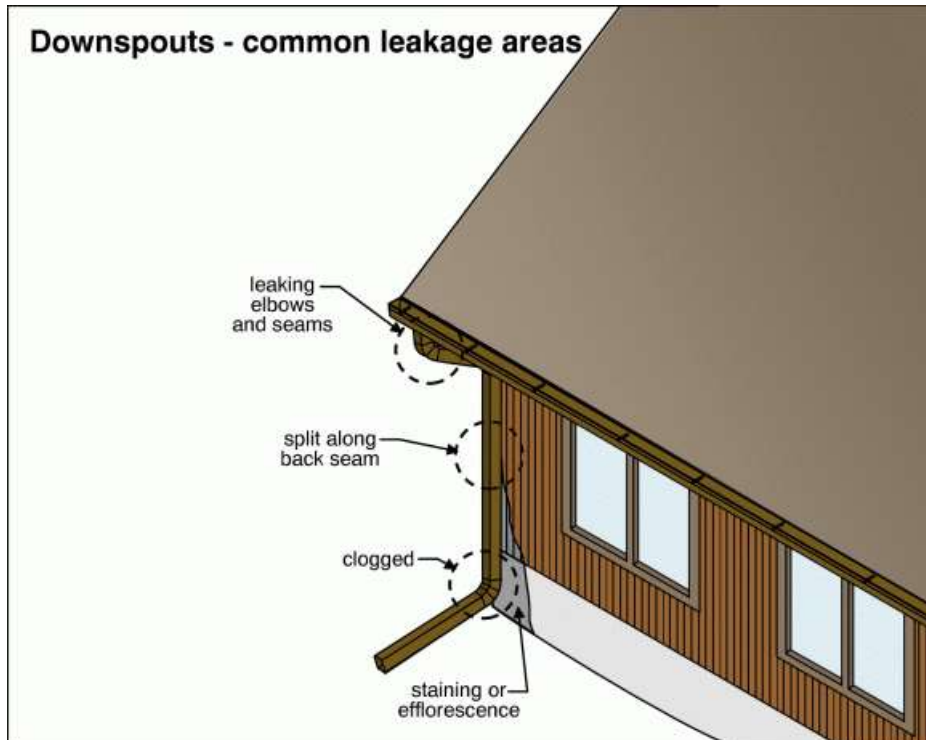
Condition: • Almost all gutters and down spouts will leak at some point to some degree. We recommend that all seams and joints be recaulked every several years, and the down spouts should discharge 4-6 feet from the foundation.

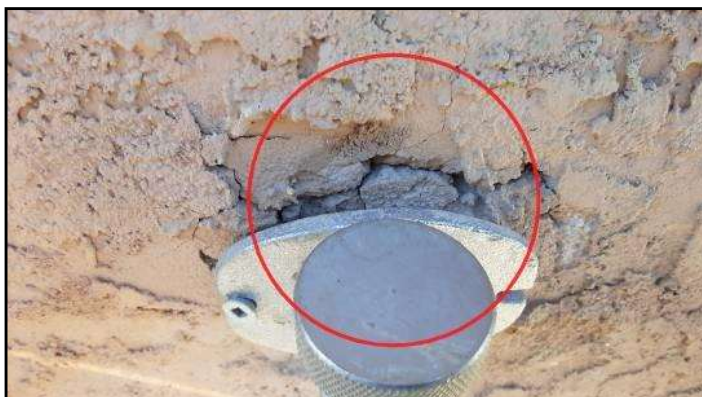
1. Cracked

Condition: • Cracked

The stucco around the hose bib is cracked. We recommend this be sealed by a qualified professional

Implication(s): Chance of water damage to structure, finishes and contents | Material deterioration

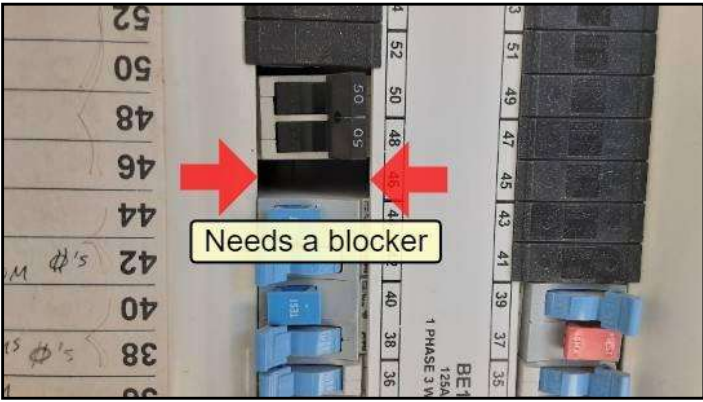
3. Openings in panel

Condition: • Openings in panel

Implication(s): Electric shock | Fire hazard

Location: Garage

Task: Repair

Time: Immediate

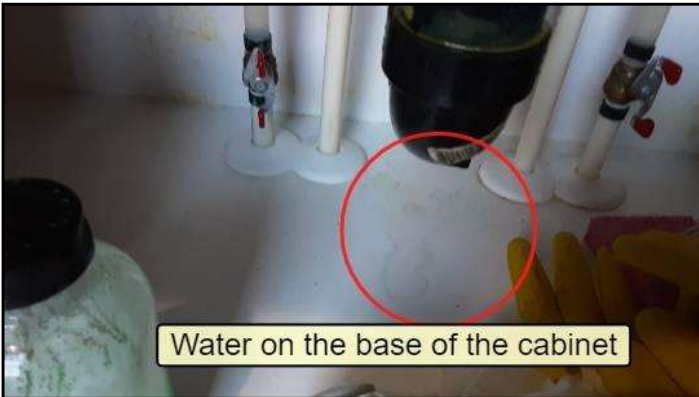
4. Leak

Condition: • Leak

The drain appears to be leaking on the master bath vanity sink. We recommend this be repaired by a qualified professional

Implication(s): Chance of water damage to structure, finishes and contents | Sewage entering the building

Location: First Floor Ensuite Bathroom

Task: Repair

Time: Immediate

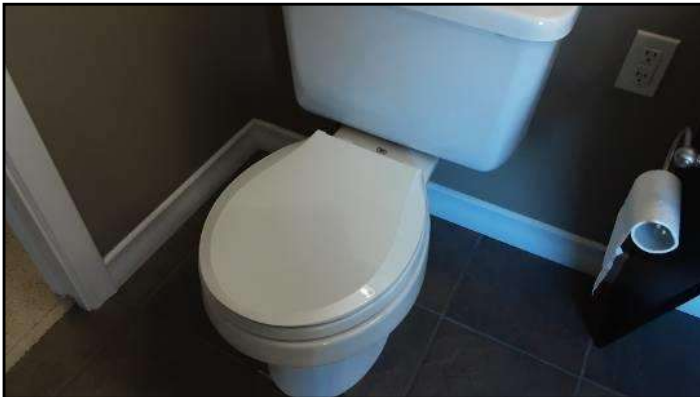
6. Loose

Condition: • Loose

Implication(s): Chance of water damage to structure, finishes and contents | Sewage entering the building | Possible hidden damage

Location: First Floor Ensuite Bathroom

Task: Repair

Time: Immediate

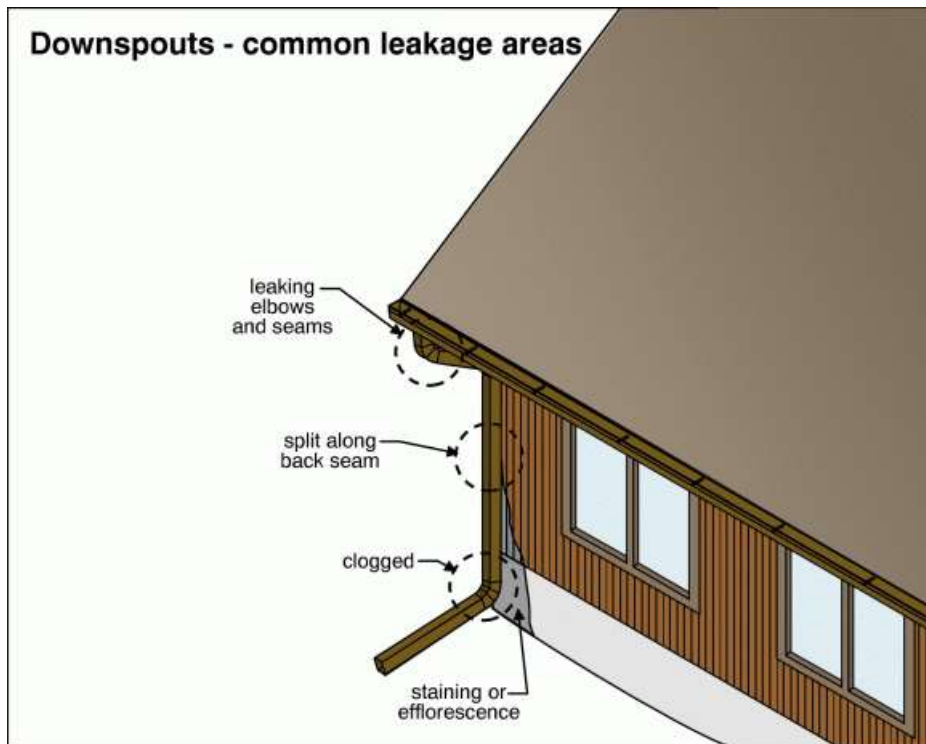
3. Condition: • Almost all gutters and down spouts will leak at some point to some degree. We recommend that all seams and joints be recaulked every several years, and the down spouts should discharge 4-6 feet from the foundation.

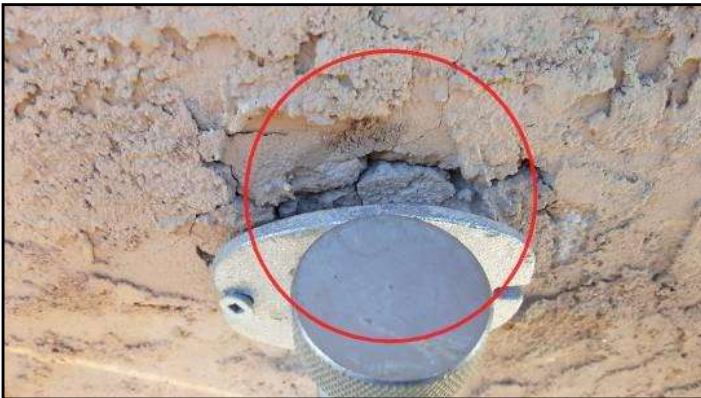
16. Cracked

4. Condition: • Cracked

The stucco around the hose bib is cracked. We recommend this be sealed by a qualified professional

Implication(s): Chance of water damage to structure, finishes and contents | Material deterioration

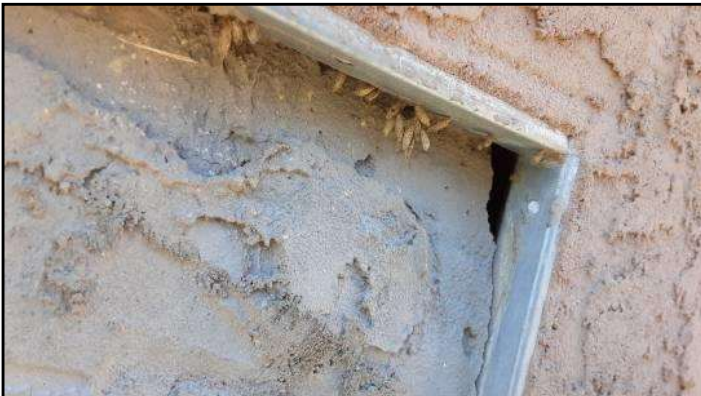
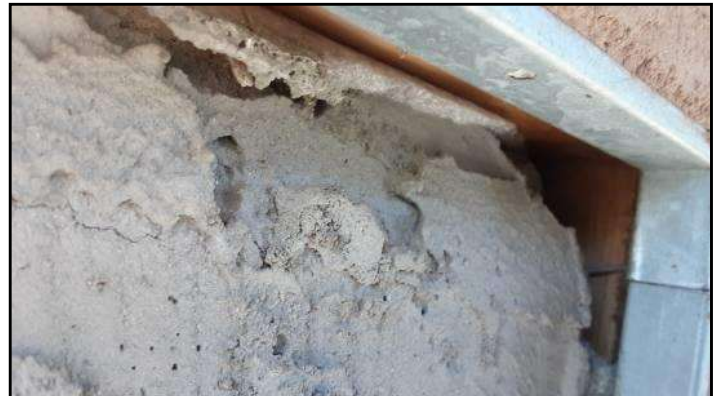
5. Condition: • Where the parging meets the stucco there is a gap, we recommend this be sealed to prevent moisture or insects from entering the cavity

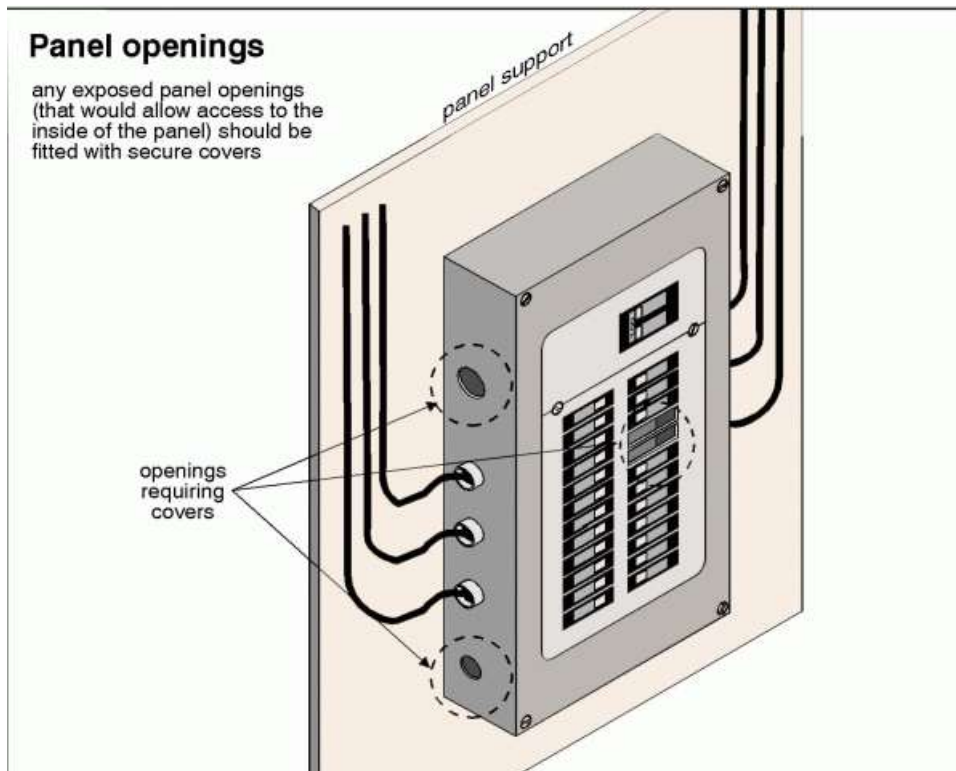
27. Openings in panel

7. Condition: • Openings in panel

Implication(s): Electric shock | Fire hazard

Location: Garage

Task: Repair

Time: Immediate

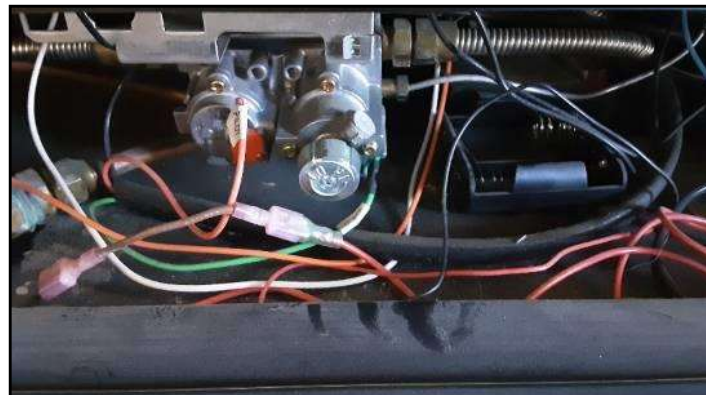
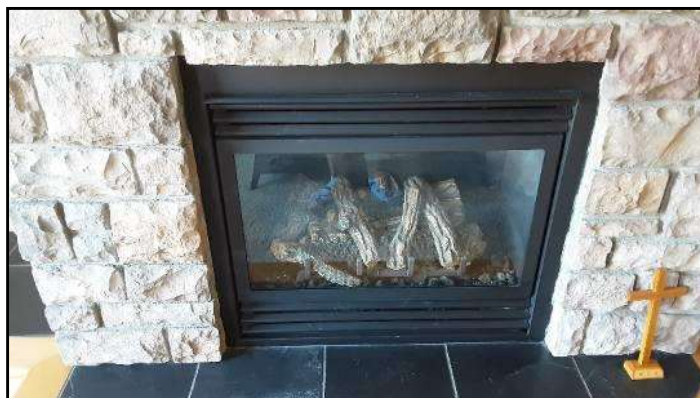
The fire place on the main floor was off. We recommend this be verified on or before possession day

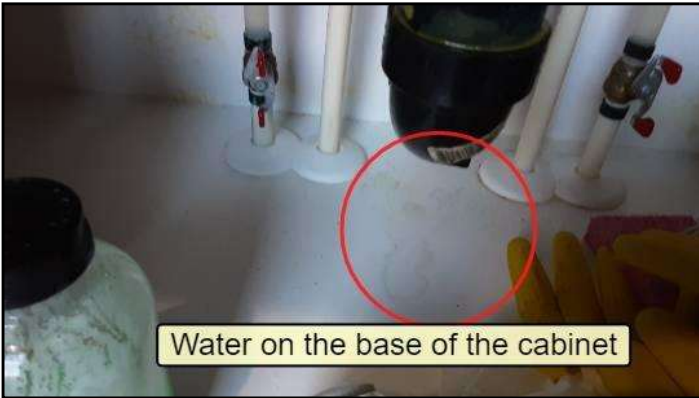
54. Leak

11. Condition: • Leak

The drain appears to be leaking on the master bath vanity sink. We recommend this be repaired by a qualified professional

Implication(s): Chance of water damage to structure, finishes and contents | Sewage entering the building

Location: First Floor Ensuite Bathroom

Task: Repair

Time: Immediate

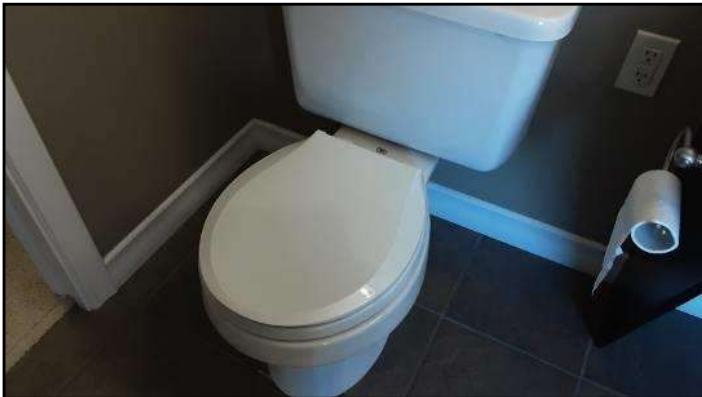
56. Loose

12. Condition: • Loose

Implication(s): Chance of water damage to structure, finishes and contents | Sewage entering the building | Possible hidden damage

Location: First Floor Ensuite Bathroom

Task: Repair

Time: Immediate
