YOUR Inspection Report

123 Your ST
Somewhere, BC

SAMPLE REPORT

Monday, December 14, 2020

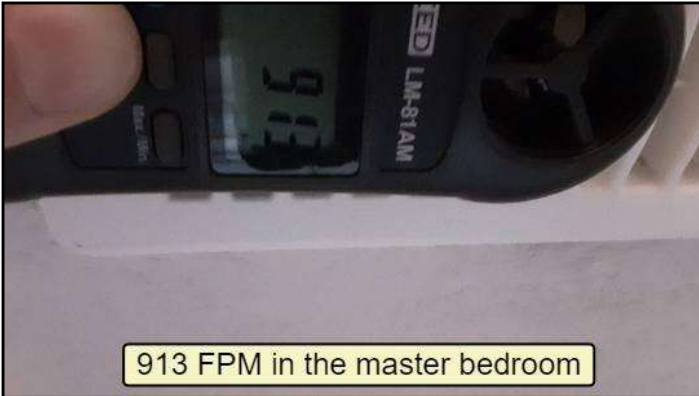
12. Furnace air flow and temperature taken at the

- Furnace air flow and temperature taken at the Master bedroom and living area

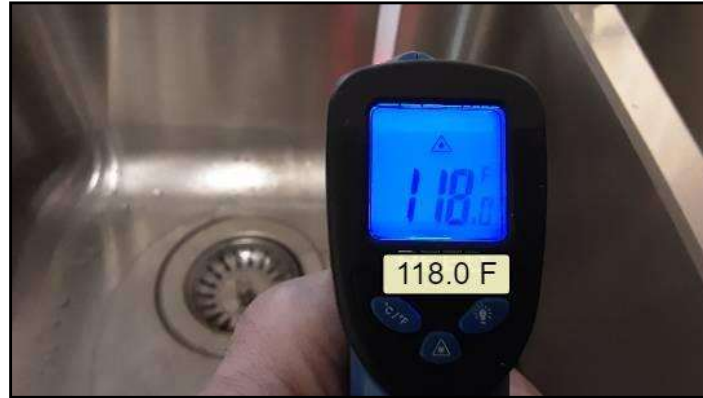
27.

General: • Hot water temperature taken at the kitchen sink

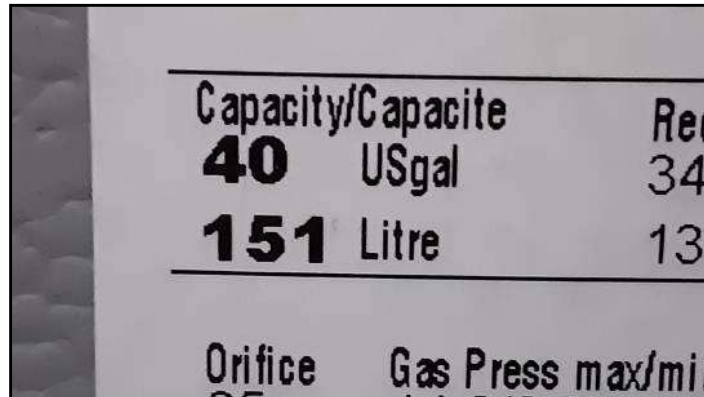
30. 40 gallons

5. Condition: • Near end of life expectancy

We recommend that a hot water heater be replaced by a qualified professional when required.
