YOUR Inspection Report

123 Your ST
Somewhere, BC

Thursday, September 3, 2020

Stix Property Inspections - Lic 80281
3211 Skyview Ln, Suite 203
West Kelowna, BC V4T 3J3

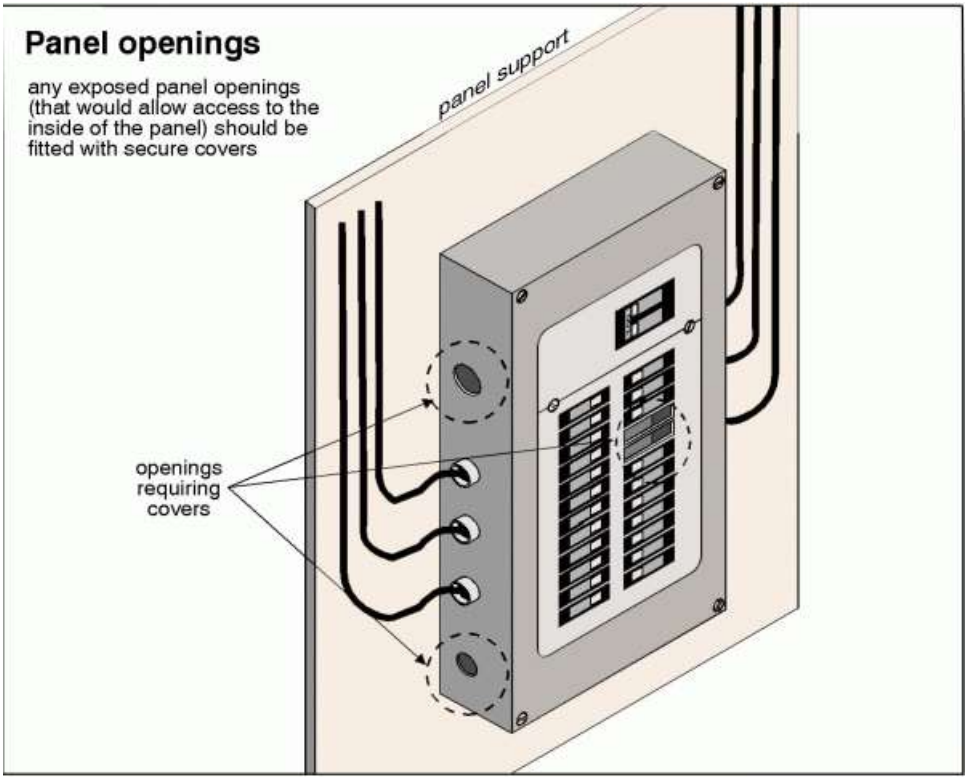
Condition: • Openings in panel

Implication(s): Electric shock | Fire hazard

3. Openings in panel

Task: Repair

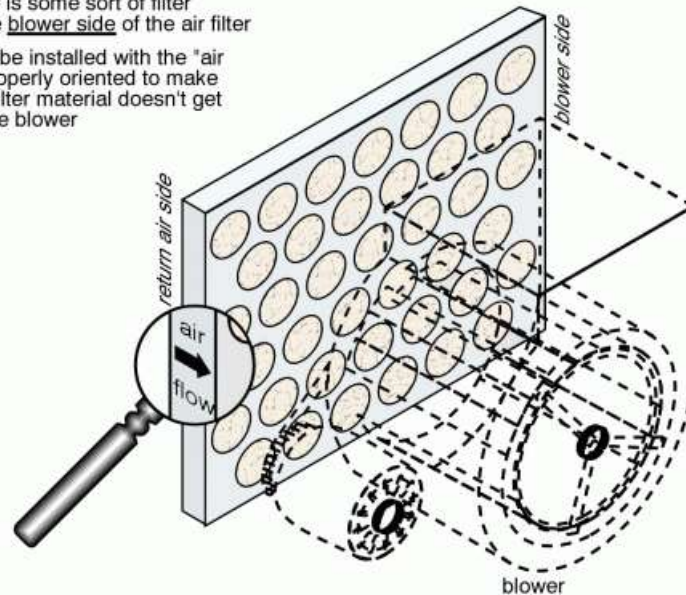
typically, there is some sort of filter support on the blower side of the air filter

the filter must be installed with the "air flow" arrow properly oriented to make sure that the filter material doesn't get sucked into the blower

Condition: • We recommend inspecting the furnace filter monthly and replace when required

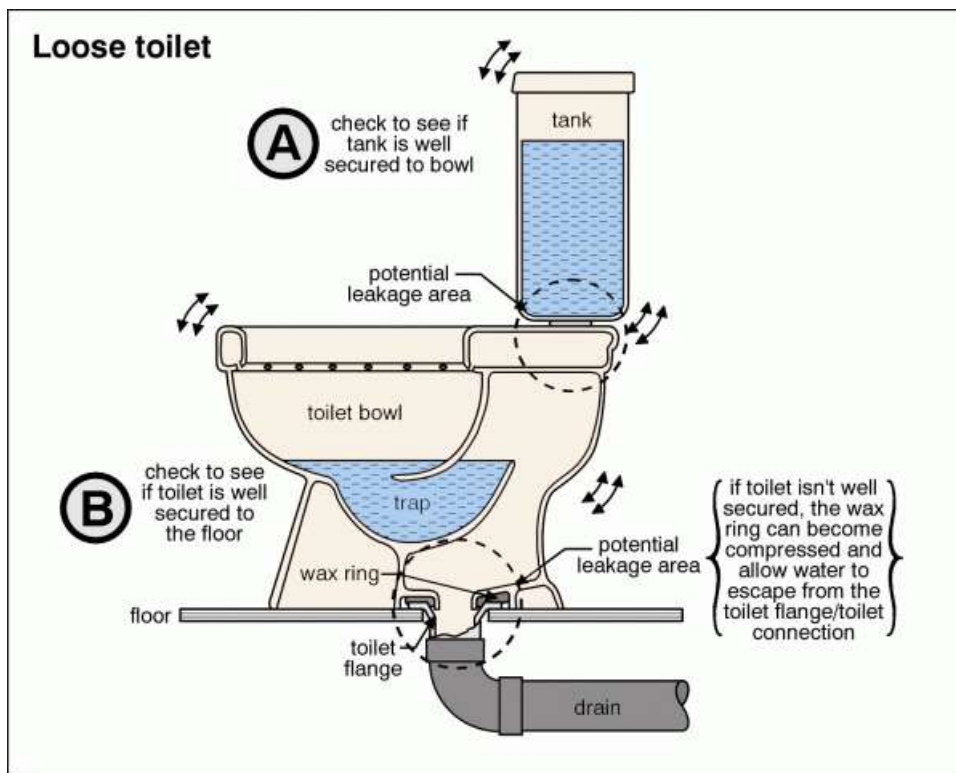
Condition: • Loose

Implication(s): Chance of water damage to structure, finishes and contents | Sewage entering the building | Possible hidden damage

Task: Repair

Time: Immediate

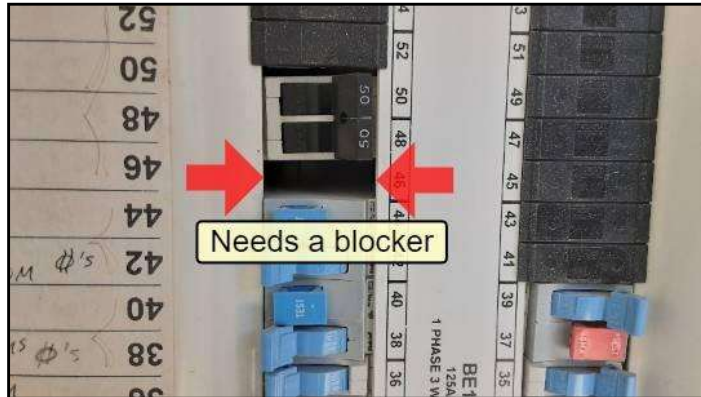
7. Condition: • Openings in panel

Implication(s): Electric shock | Fire hazard

27. Openings in panel

Task: Repair

Time: Immediate

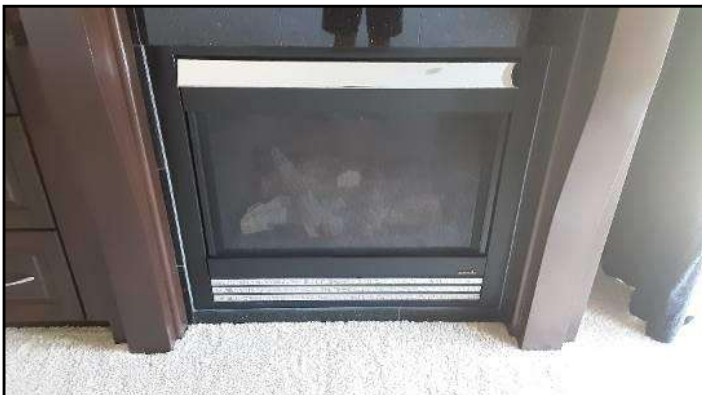
The lower level fire place is turned off and no batteries for the controller. We recommend verifying this functions normally on or before possession day.

35. Gas fireplace

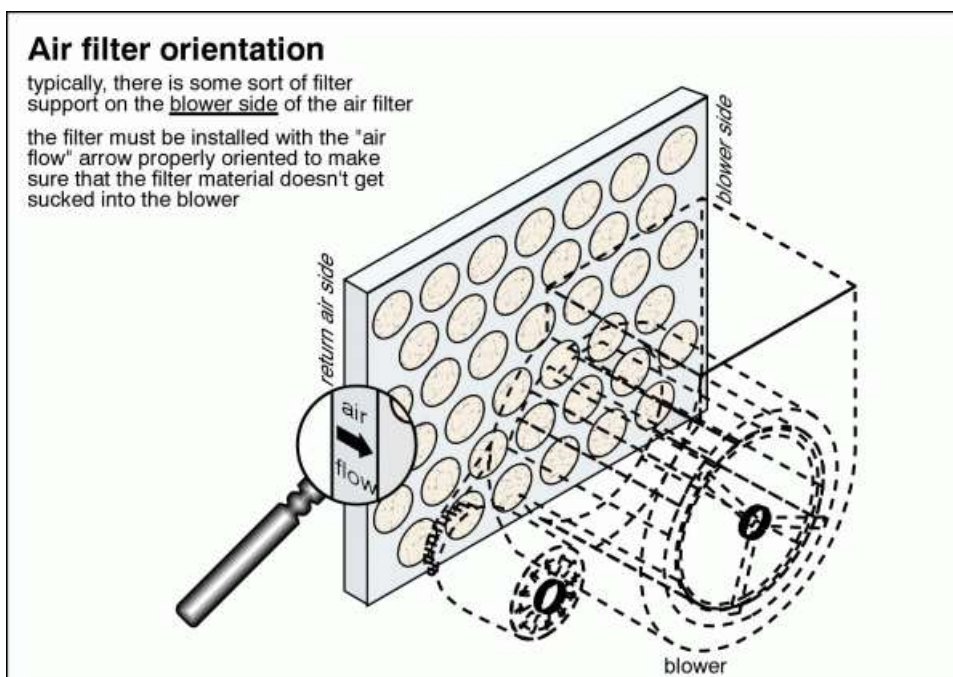
8. Condition: • We recommend inspecting the furnace filter monthly and replace when required

Implication(s): This will help maintain the comfort in your home.

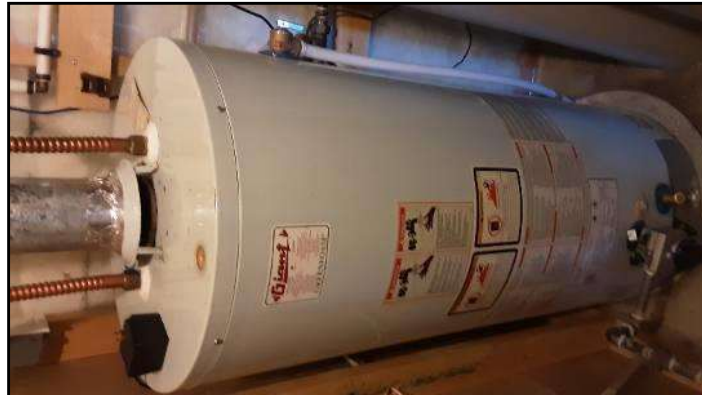
51. Conventional

The hot water tank was built in 2009, there maybe issues with insurance because it is nearing end of life use. We therefore recommend it be replaced by a qualified professional

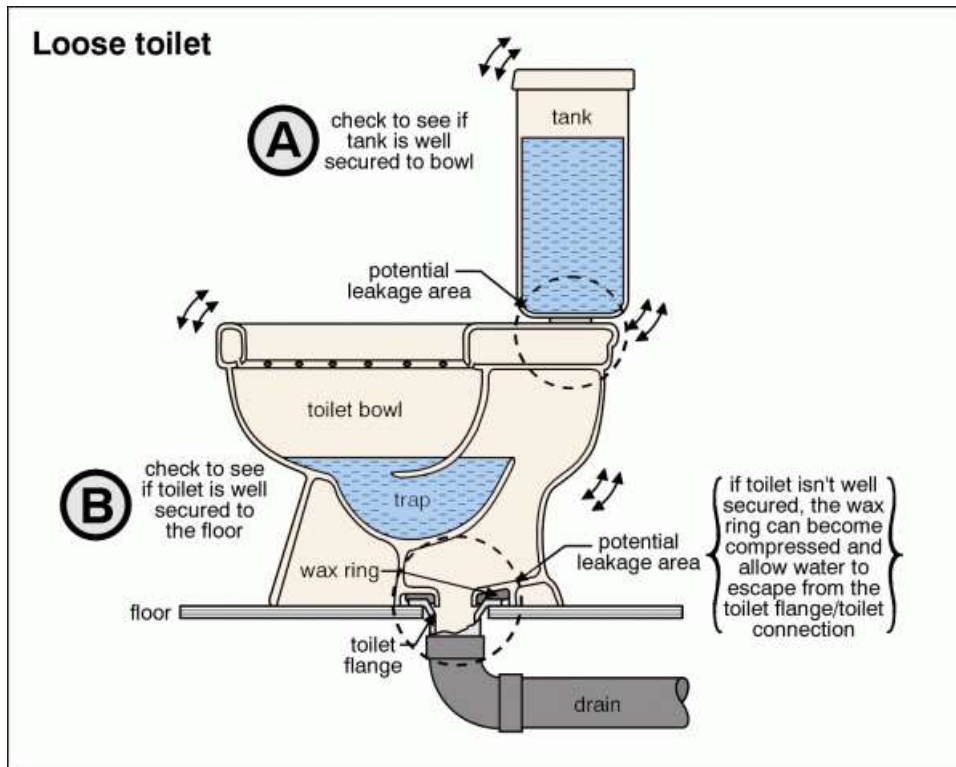
12. Condition: • Loose

Implication(s): Chance of water damage to structure, finishes and contents | Sewage entering the building | Possible hidden damage

Task: Repair

Time: Immediate
