YOUR Inspection Report

123 Your St
Some Where, BC

Friday, January 8, 2021

Report No. 1190

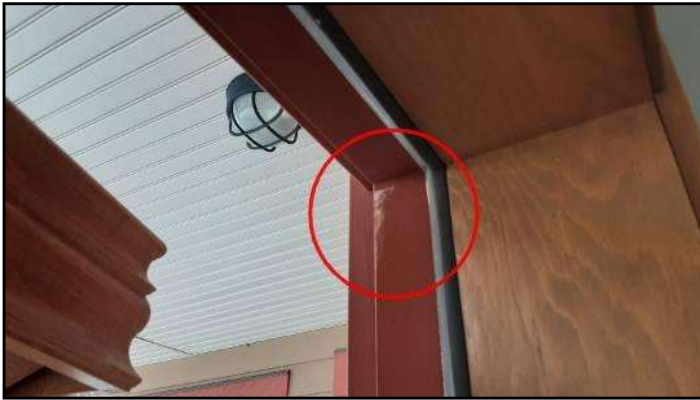
Condition: • Binds

9. *Binds*

Task: Repair

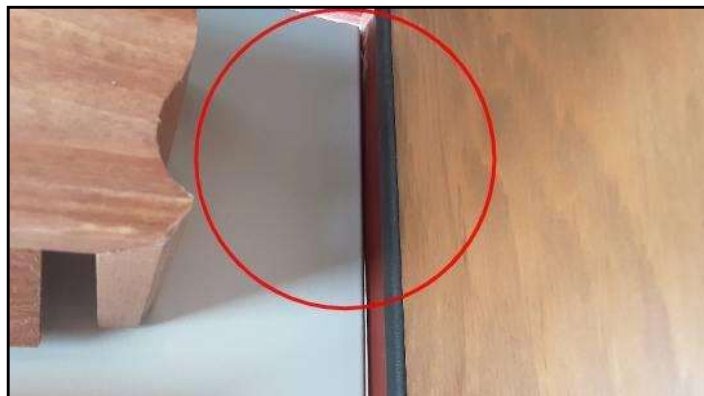
68. Binds

13. Condition: • Binds

Task: Repair
